EVALUATION OF DESIGN AND CONTROL ALTERNATIVES TO IMPROVE SAFETY OF  
INTERSECTIONS OF MULTI-LANE HIGHWAYS WITH OTHER HIGHWAYS

July 1, 1981  
Revised Dec. 28, 1981  
Project: C-36-59X

Project No.: C-36-59X

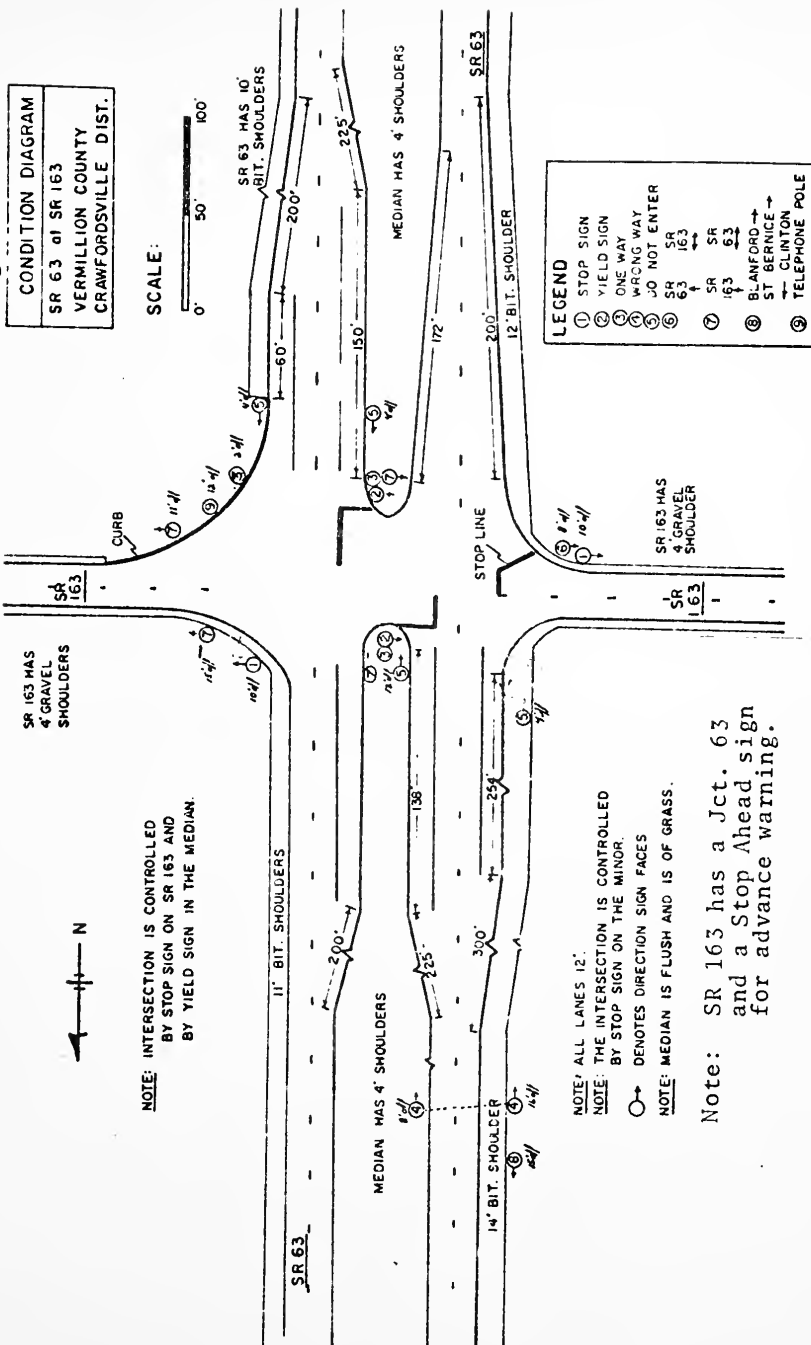
Figure 1-1.

Primary Cause - Poor visibility of flashers on S.R. 63.

Other Possible Causes - Inadequate warning to S.R. 163 traffic, confusion on the part of left-turning vehicles.

The accident history at this intersection does not justify expensive reconstruction such as left-turn slots through the median. Our recommendations are to relocate the flashers over the lane lines and to increase the wattage in the bulbs.

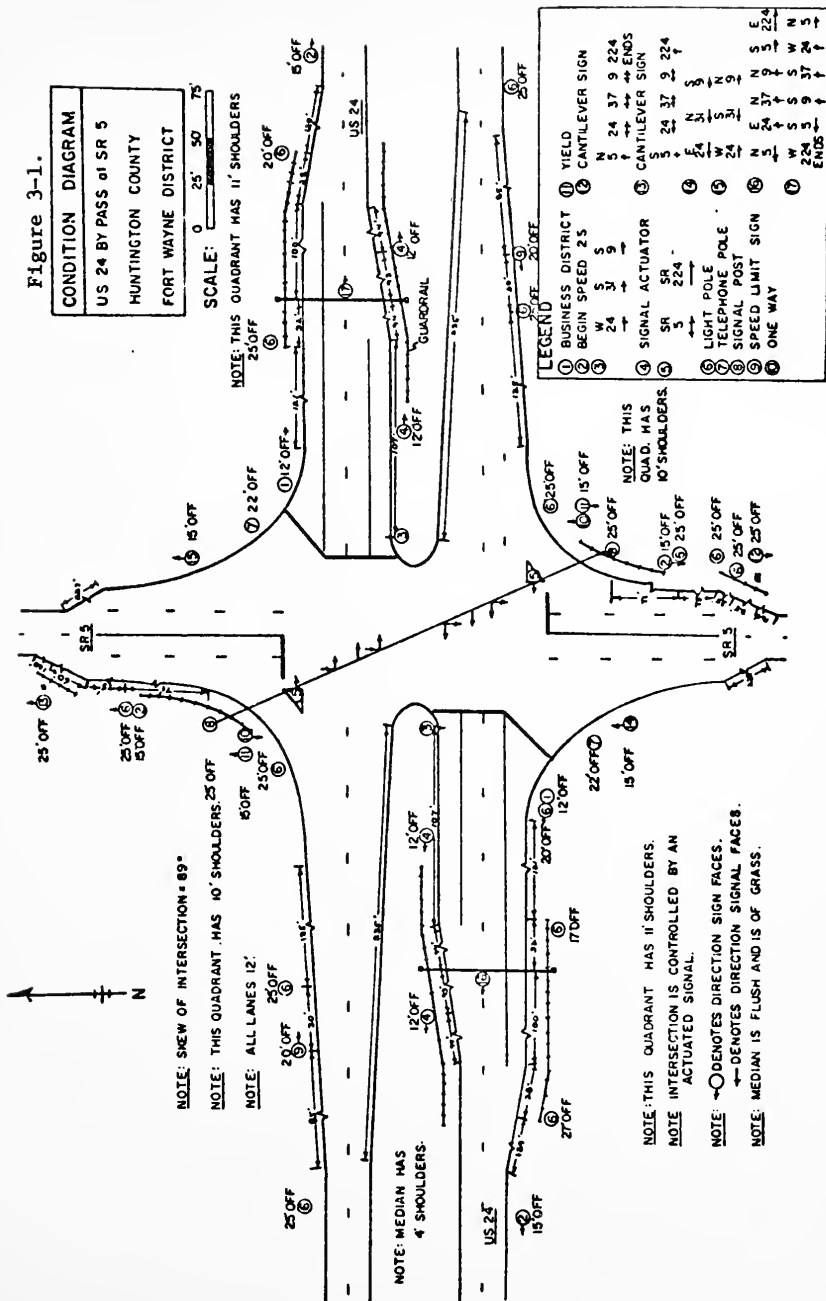
Figure 3-1.

Primary Cause - Unexpected signal. The team members agreed that visibility at this intersection was good, but that because of its isolated location relative to other signals on U.S. 24 motorists were not expecting the signalized intersection and were travelling too fast to stop, either for the signal itself or because other vehicles were already stopped.

Other Possible Causes - Traffic signals obscured by overhead route signs, left-turn vehicles on U.S. 24 Bypass not in storage lanes, right-turn vehicles on S.R. 5 not in storage lanes, distracting environment due to excessive signage.

Consensus Countermeasure - Provide a high-type of advance warning signs on all approaches.

Other Possible Countermeasures - Relocate overhead route signs, lengthen U.S. 24 Bypass left-turn storage lane, lengthen and widen S.R. 5 right-turn storage lane, add black blanks to signal heads, add strobe light to signal.

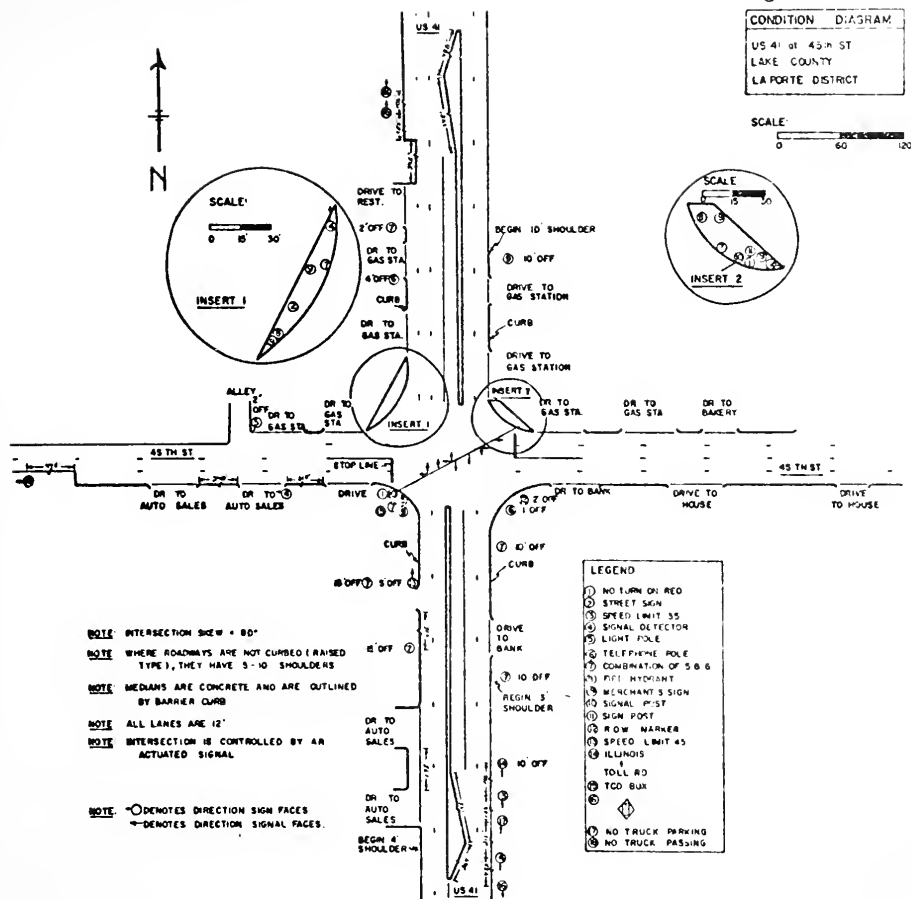
Figure 9-1.

This intersection has had a very serious accident history. The large number of rearend accidents on all approaches to the intersection indicates that drivers are not prepared to stop, either for the signal when it changes or for vehicles ahead which do stop for the signal. Our recommendations are to install the signals in a box configuration, provide overhead advance warning signs on U.S. 41, and to install advance warning signs on 45th Avenue in each direction.
